First Degree Fitness

Speed Sensor Trouble Shooting and Replacement Guide for Pacific Challenge AR, Newport Challenge AR and Trident Challenge AR

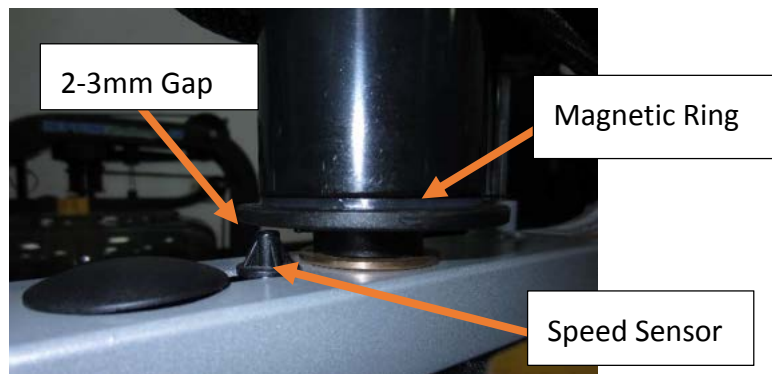
1. Check the gap between sensor and magnetic ring should be 2-3mm

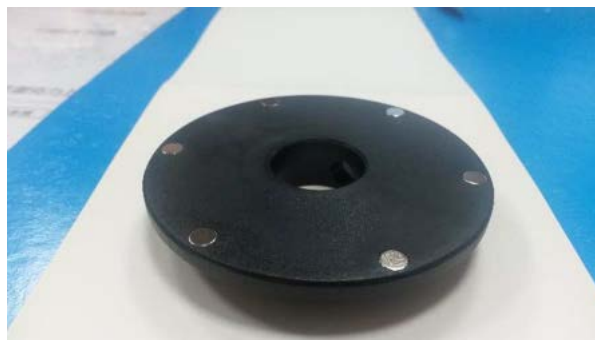
2. Visually check all 6 magnets in the magnetic ring are present and flush (no need to remove the ring)

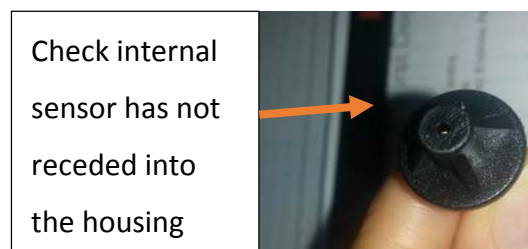
3. Check sensor head – the internal sensor should be no more than a few millimeters inside the hole
