**Remove/Replace the PK drive belt:  
Applies to E520/E720/E820/E920 and VX-3**

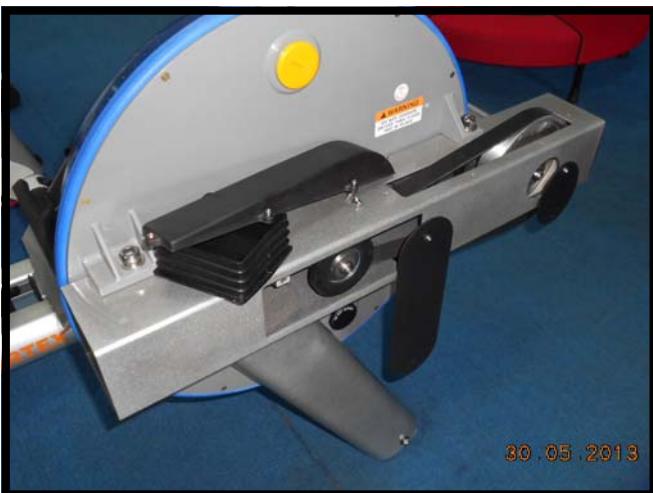
First Remove both inspection covers and the rear end cap. Note the rear end cap can either be pushed out from inside, or removed with a flat head screwdriver or other implement. Use care not to damage finish or cap when doing so.

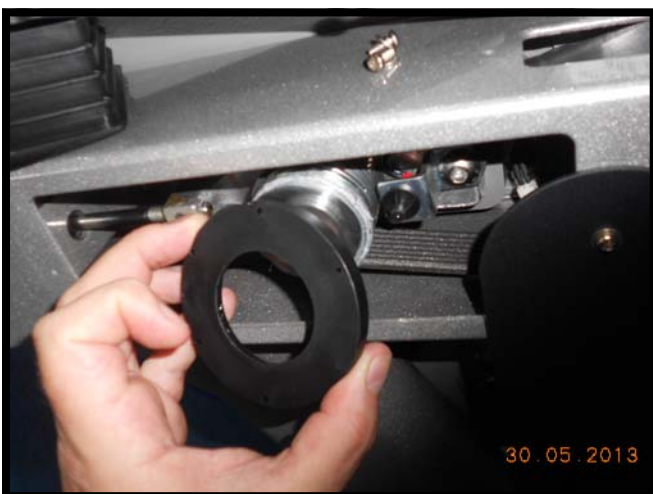
Next, remove the upper (and lower if you choose) belt covers as shown.

Then, remove the magnetic ring. It will be held in place by a light dab of silicone from the factory.

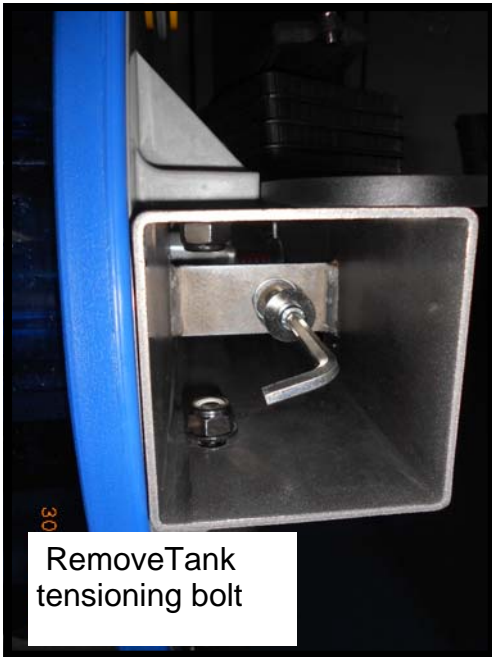
Remove Tank tensioning bolt

Next remove the tank tensioning bolt with the 6mm Allen key. Once the tank tensioning bolt has been removed, loosen (but do not remove) the three tank bolts holding the tank to the frame.

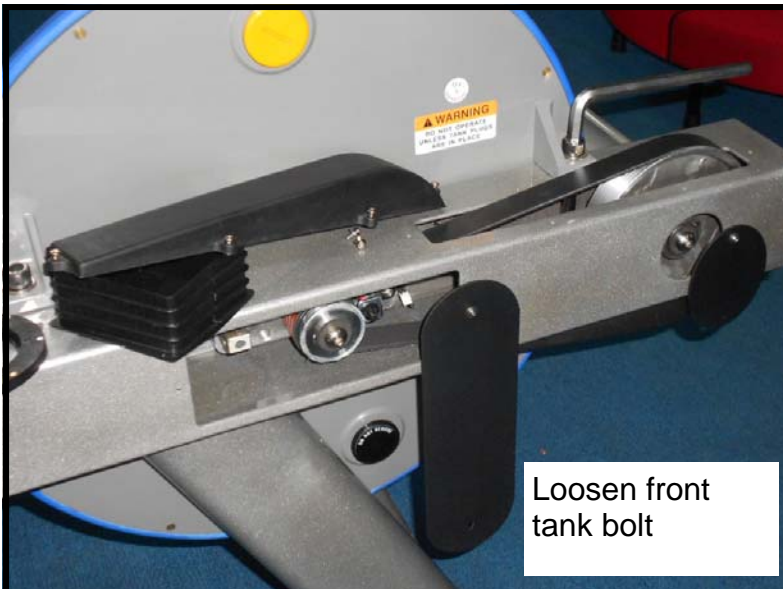
Loosen front tank bolt

Once the tank bolts are loosened, remove the front portion of the tank outer rubber ring. This gives you enough room to push the tank forward and un-tension the belt prior to removal.

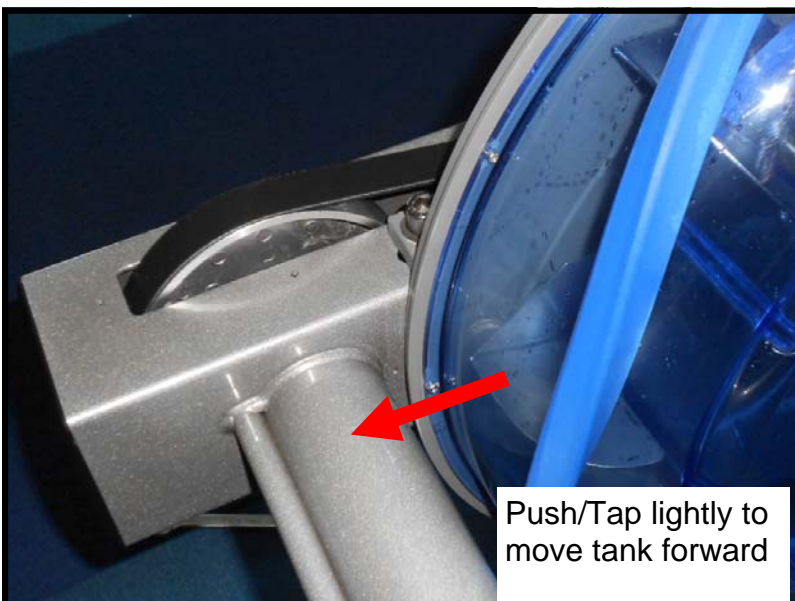
Push/Tap lightly to move tank forward

You may, depending on the unit, be able to slide the tank forward by hand, but sometimes will require some persuasion with a light tap from a rubber mallet.

**Caution:** Leave the rear of the tank outer rubber ring in place and use this location to tap the tank forward to avoid damaging either the tank back or shell.

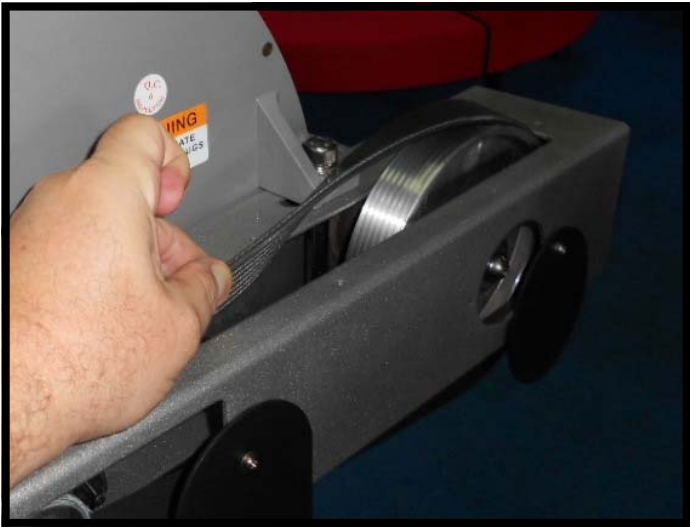
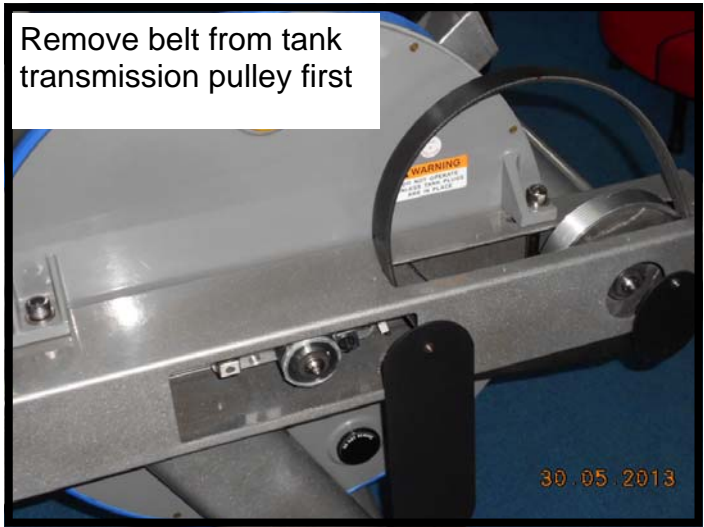
Once the tank is furthest forward, remove the belt first from the transmission pulley on the tank using care not to damage/move the sensor bracket/wiring.

Next, remove the bottom rubber cover if you have not done so already.

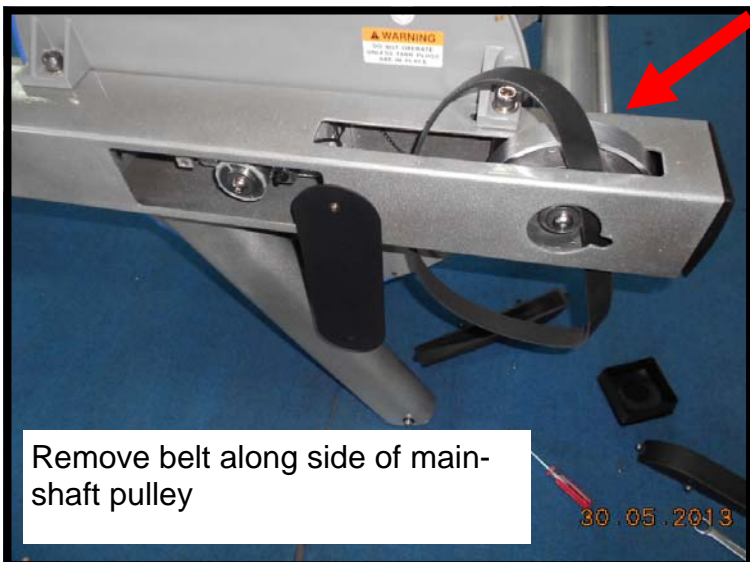
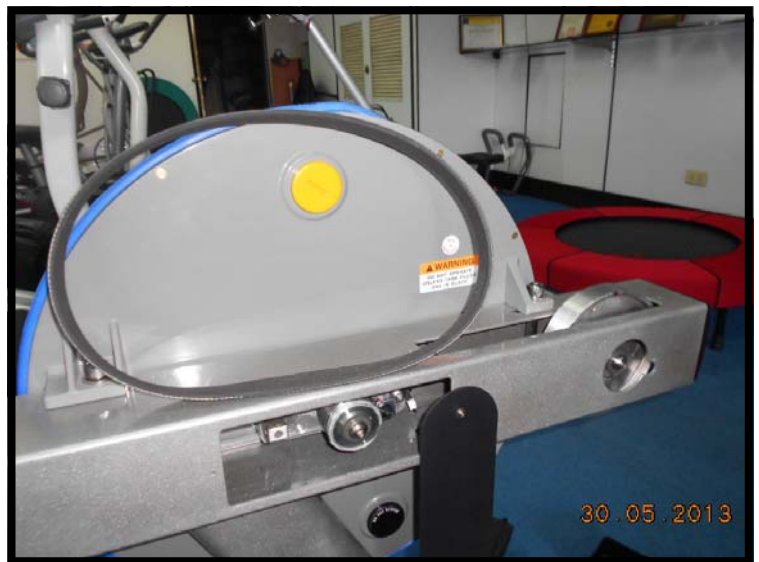
This bit is tricky, but it will go. Manipulate the belt off the mainshaft pulley and to the side as shown. It's tight, but it will pass. Once past the center of the mainshaft pulley, the belt is easily removed.

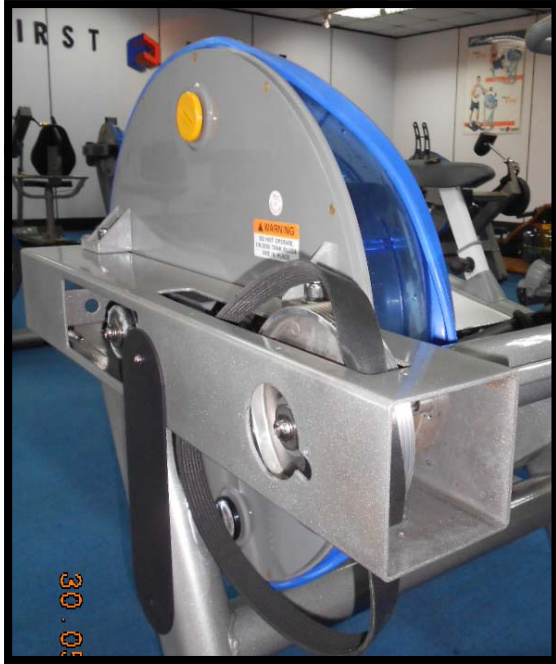
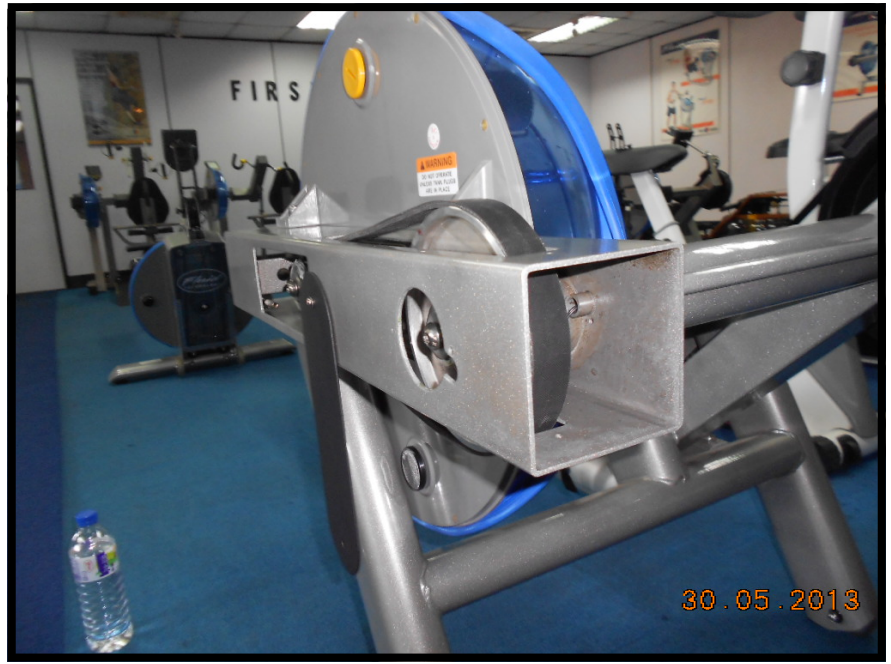
Manipulate the replacement belt along the side of the mainshaft pulley, and back into position. Feed the rear onto the tank transmission pulley, taking note of proper alignment.

Next, (without tightening tank bolts) reinstall and tighten tank tensioning bolt until two threads protrude from back of tank Aluminum housing as shown. This is roughly equal to 250psi and will tighten sufficiently to prevent slippage during hard rowing.

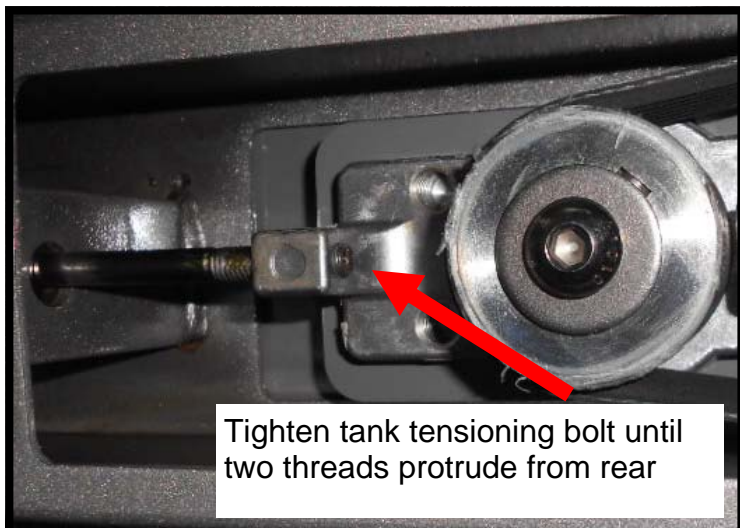
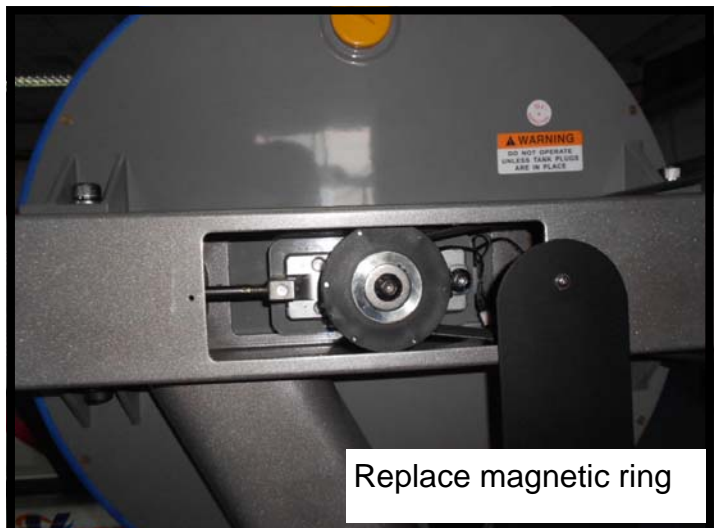
Replace magnetic ring. This is the time to test the rower for proper functionality. Make sure the computer signal is consistent and belt alignment correct before replacing end caps, inspection covers and tank cover ring. Glue magnetic ring in place.

Finally, tighten tank bolts LIGHTLY. Over tightening can damage the tank back.
